Manhole Inspection Summary

Manhole # S29II1011MH

Insp Date: **4/16/07 11:55 AM**

Location Address: **4214 WICKFORD RD**

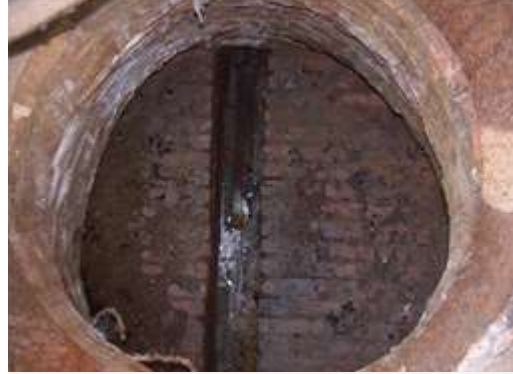
Top View

Corroded and missing steps. Evidence of surcharge - Bench debris.

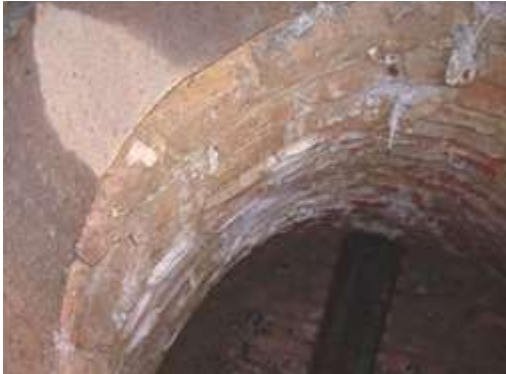
Defect

Corbel deterioration and infiltration.

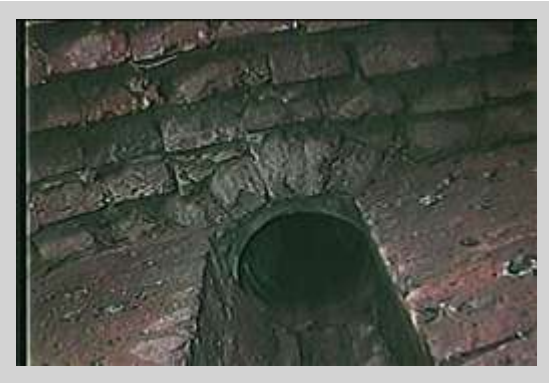
8 in. Circular Gravity Sewer Pipe Out @ 12 O'Clock

Barrel deterioration and infiltration.

Infiltration: **Evidence** Pipe Seal Cond: **Cracked**

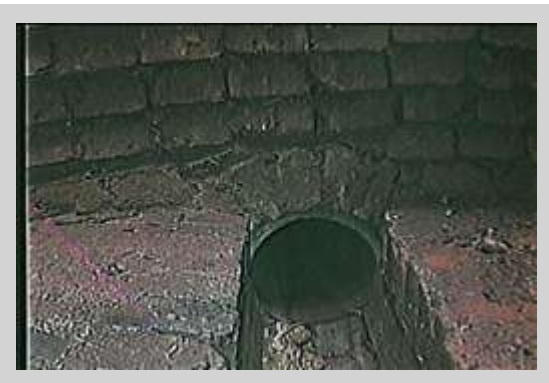
8 in. Circular Gravity Sewer Pipe In @ 7 O'Clock

Barrel deterioration and infiltration. Channel deterioration.

Infiltration: **Evidence** Pipe Seal Cond: **Cracked**
